Attorney Docket No.: DRE-0055  
Inventors: Laurencin et al.  
Serial No.: 09/878,641  
Filing Date: June 11, 2001  
Page 5

# Analysis of retrieved polymer fiber based replacements for the ACL

The present retrospective analysis of 117 surgically excised anterior cruciate ligament (ACL) prostheses was designed to elucidate the etiology and mechanisms of failure of synthetic ligamentous prostheses. They were harvested from young and active patients (26 ± 7 yrs) at various orthopaedic centers in France between 1983 and 1993. The average duration of implantation of augmentation and replacement prostheses were 21.5 ± 12.6 and 33.2 ± 25.3 months, respectively. The principal causes for their excision were ruptures and synovitis. Each ACL prosthesis was examined macroscopically, histologically, and, after tissue removal, by scanning electron microscopy (SEM) to determine the model, manufacturer, surgical technique used at implantation, the extent of healing, the site of rupture, and the morphology of the damaged fibers. Fourteen types of ACL prostheses were analysed, each fabricated using a different combination of polymers, fibers and textile constructions. Consequently, they generated a

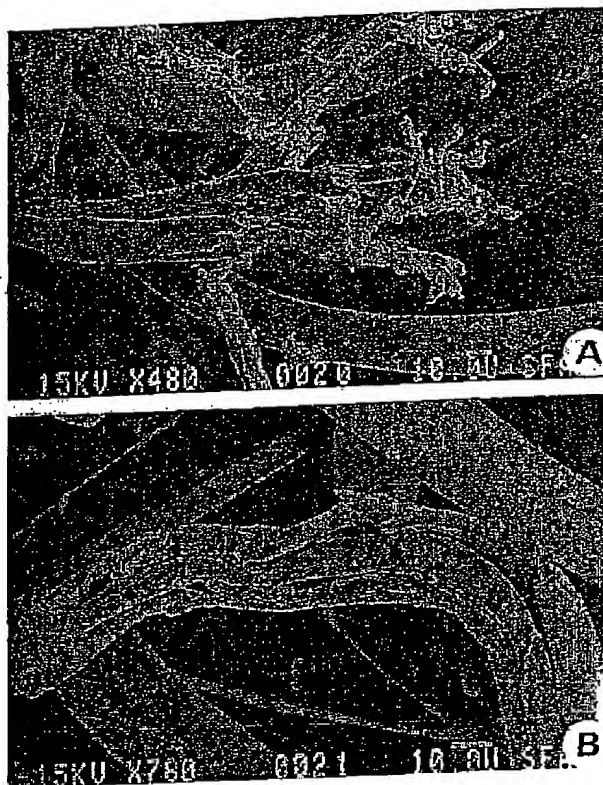
Fig. 12. Scanning electron micrographs of polyester fibers taken from the envelope of explanted Lygeron prostheses after cleaning showing a fracture morphology with multiple axial splitting and bushy ends (A:  $\times 480$ ). Fiber splitting due to flexural and torsional fatigue was also noted (B:  $\times 780$ ).

Some fibers with bushy ends were found within the ruptured regions. Fibers exhibiting axial splittings and surface peeling were common to all of the prostheses, suggesting that both flexural fatigue and surface abrasion had contributed to the failure (Fig. 12). As seen from the Stryker® and the Proflex® grafts, there was no evidence of deterioration due to abrasion between the outer shell and the internal ribbons, and in fact the extent of damage was similar in both layers.

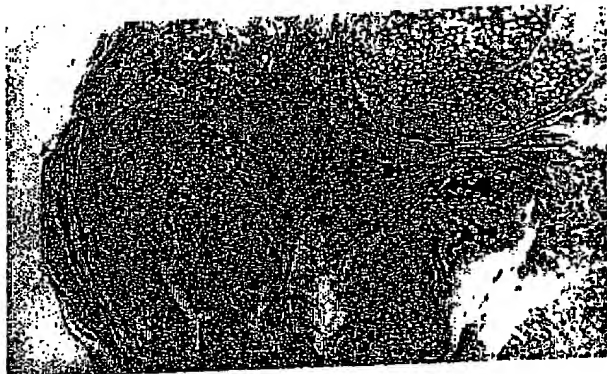
Fig. 17. Light photomicrograph of a cross-section of an explanted ABC Surgicraft PET prosthesis after 48 months of implantation. The collagenous tissue originating from a thick external capsule penetrated between the braids and occasionally between individual fibers (arrow). The black material observed within the braids was an amorphous proteinaceous across substance ( $\times 62$ ).

The histological study revealed that the ABC Surgicraft® PET prostheses were well encapsulated by collagenous tissue, which penetrated to the core of the ligament between the 24 separate braids. Most of these prostheses also showed that the tissue was responsible for separating the yarns within a braid, but not the fibers

within a yarn (Fig. 17). The inflammatory response was moderate and chronic, with macrophage and giant cells in contact with the fibers.

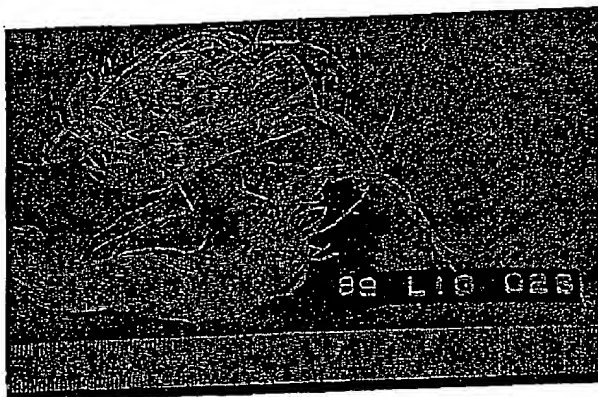
Fig. 19. Macroscopic view of an explanted Goretex prosthesis (89lig026) showing a break in the intra-articular zone with significant tearing and fraying of the ligamentous structure.

**Gore-Tex® ligament:** Three braided Gore-Tex® ligaments implanted for an average of  $31.6 \pm 2.8$  months ( $n = 2$ ) were installed using the through-the-condyle technique between 1987 and 1988 and explanted following rupture in the intra-articular zone (Fig. 19). Histological observations revealed that loose collagenous tissue surrounded the ligament and penetrated between individual fibers (Fig. 20). The extent of collagen infiltration was limited to the periphery of the device. This type of prosthetic ligament showed no evidence of an inflammatory reaction.
